Contract #: 04-0120F4Cty: SF/ALA Rte: 80 PM: 13.2/13.9File #: 69.28**WELDING INSPECTION REPORT****Resident Engineer:**Pursell, Gary**Address:** 333 Burma Road**City:** Oakland, CA 94607**Report No:** WIR-011881**Date Inspected:** 28-Jan-2010**Project Name:** SAS Superstructure**OSM Arrival Time:** 645**Prime Contractor:** American Bridge/Fluor Enterprises, a JV**OSM Departure Time:** 1845**Contractor:** Zhenhua Port Machinery Company, Ltd (ZPMC), Changxing Island **Location:** Shanghai, China

WELDING INSPECTION REPORT

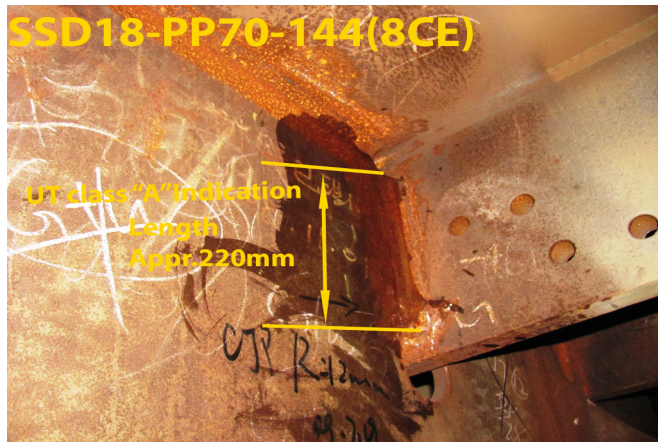
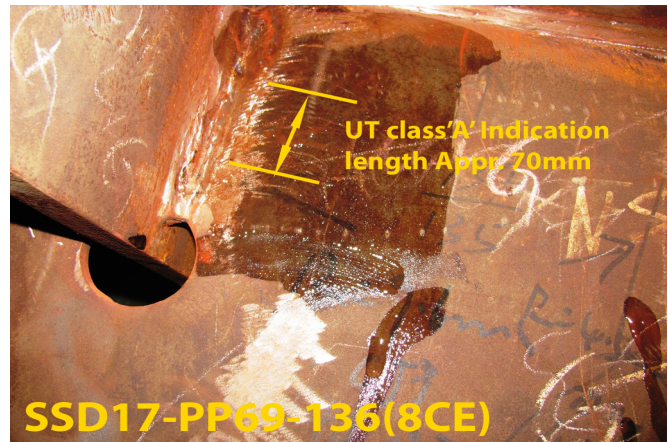
During the Quality Assurance Ultrasonic Testing (UT) review of welds located on Orthotropic Box Girder (OBG) segment 8CE, this Quality Assurance Inspector (QA) discovered that Two (2) Class "A" longitudinal indications measuring approximately 70mm and 220mm in length. The indication db ratings are +4 and -3 respectively.

Material thickness is 18mm. The depth of the indications are approximately 14mm and 11mm.

The 1st weld is identified as SSD18-PP70-144 at Panel Point PP70 Crossbeam Side. The 2nd weld is identified as SSD17-PP69-136 at Panel Point PP69 Crossbeam Side. The welds are designated as Seismic Performance Critical Material (SPCM). The indications found are clearly marked near the weld. The Y locations are 70 mm and 0mm when measured from the deck plate. The welds are shown as fillet welds on the contract drawings but due to excessive gaps at the time of fit up were changed to Complete Joint Penetration (CJP) "T" joints.

The 1st joint joining Floor beam FB28A(X12H) SPCM to Deck plate 'I' stiffener RS62HA (Non SPCM). The 2nd joint joining Floor beam FB24A (X25B) SPCM to Deck plate 'I' stiffener RS62HA (Non SPCM).
